## FIRST FIVE YEAR REVIEW REPORT

### KENNECOTT SOUTH ZONE

OU 1 Bingham Creek  
OU 4 Large Bingham Reservoir  
OU 5 Copperton Tailings  
OU 10 Copperton Soils  
OU 11 Bingham Canyon  
OU17 Bastian Sink

June, 2004

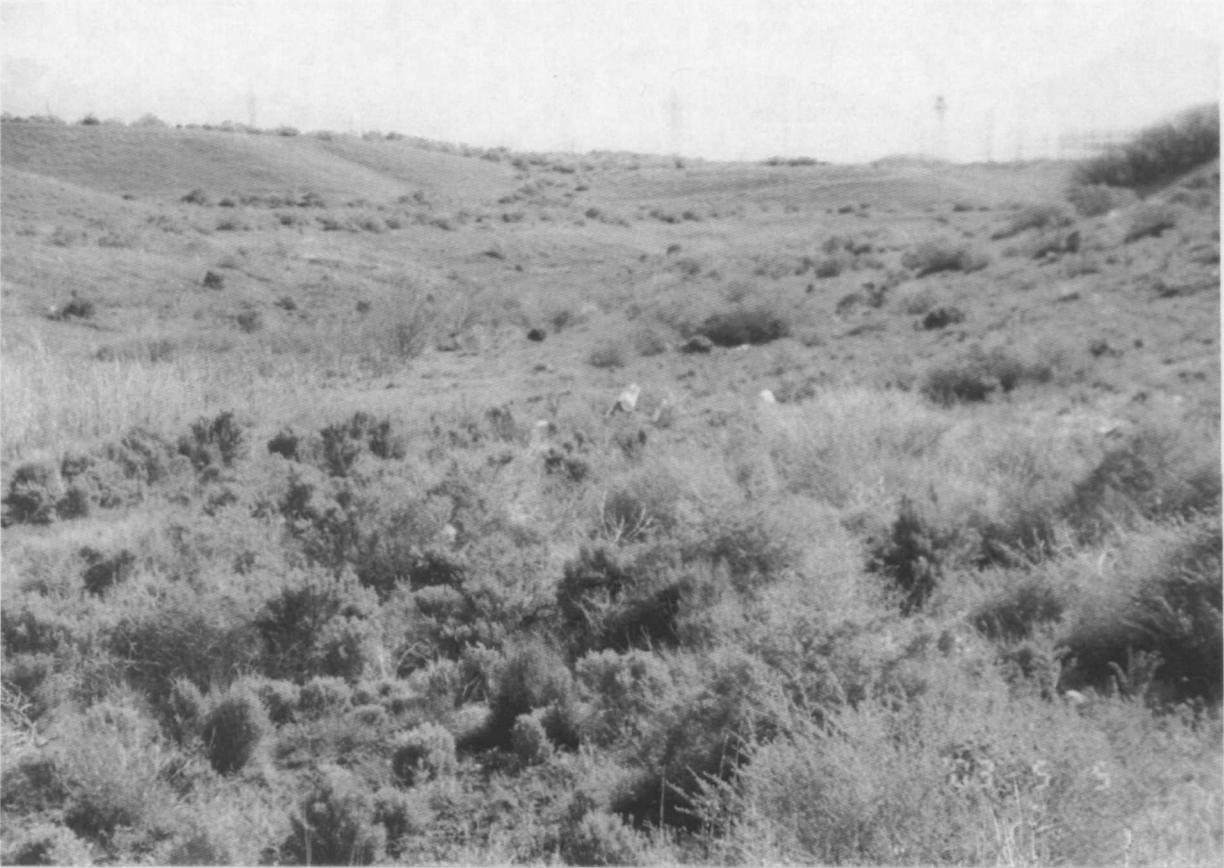
4. With very few exceptions, the revegetation efforts along the creek channel, in the residential neighborhoods, and in the new developments are in excellent shape. It is difficult to see that the area had ever been disturbed by the cleanups. In many cases, the vegetation is healthier than was there before the cleanups.

**Figure 7:** Revegetation of Bingham Creek

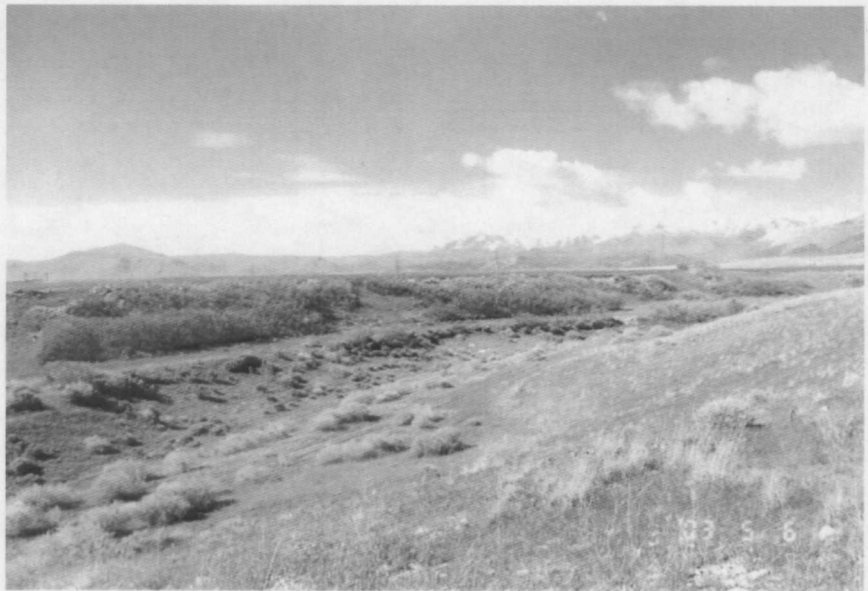
**Figure 9:** Revegetation of Creek Channel

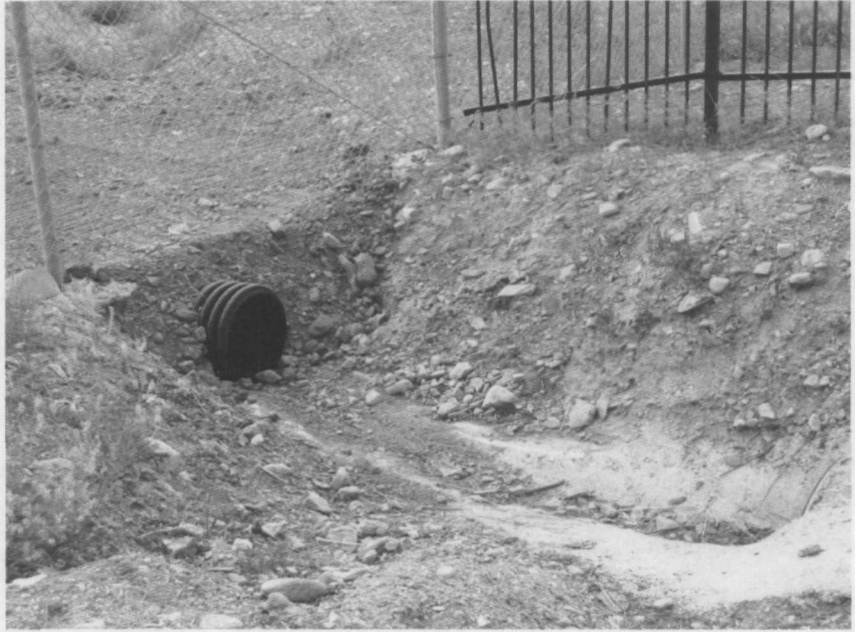
1. The cap covering the wastes in Bingham Creek Channel was experiencing erosional degradation at one location near Route 111 and the Trans Jordan Landfill. Although the erosion gully had not yet gotten deep enough to uncover the tailings, it was clear that this would be inevitable without intervention of some kind. In all other locations, the cap was undisturbed by erosion. (This erosion gully was filled in by a joint action by the Trans Jordan Landfill, the City of South Jordan, and Kennecott. The runoff water is now diverted to a pipe which carries the water underground to the channel. See Appendix D.)

**Figure 10:** New inlet for road runoff to Bingham Creek

The team recommended that the erosional gully found where drainage from the access landfill road and Rt. 111 discharges into the creek channel be repaired before the erosion cuts completely through the cap and exposes the tailings underneath. As a result of this recommendation, the Trans Jordan Landfill management was contacted by EPA. The landfill general manager agreed to repair the problem with the help of the City of South Jordan (which now maintains Rt. 111), and Kennecott, the landowner.

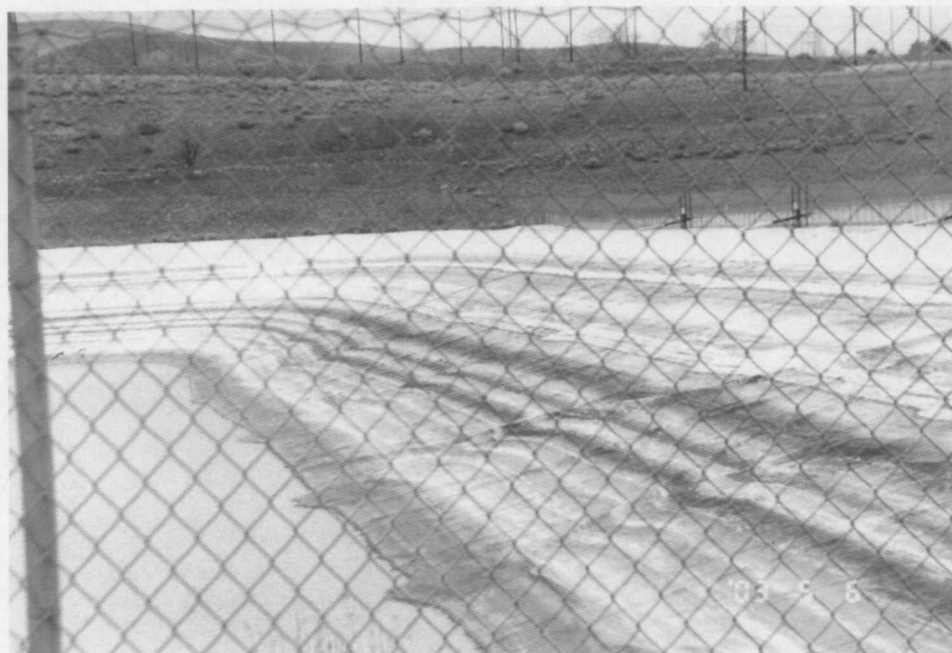
**Figure 13:** Zone 1 of the Large Bingham Reservoir showing different water levels

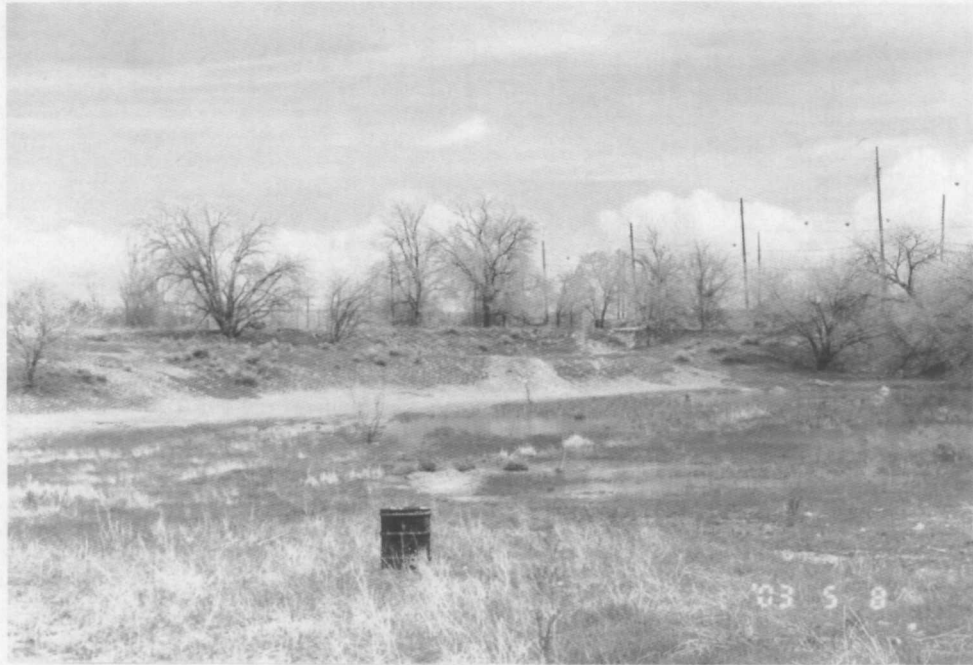
**Figure 17:** Remnants of mining wastes still visible in industrial area. (The barrel has been removed.)

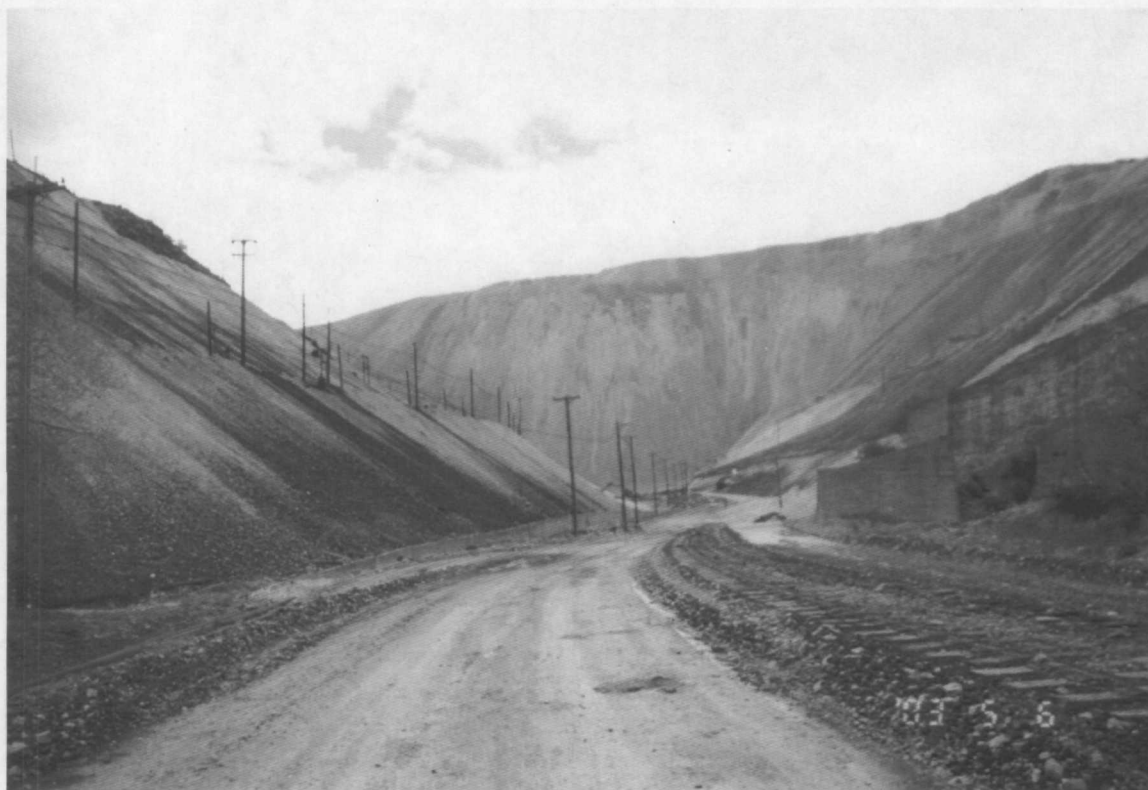
The historic Utah Copper Mill foundations and recently removed rail corridor up Bingham Canyon. The toe of the Bingham Mine dumps in the canyon are in the background. Since this photo was taken, the entire area has been buried by waste rock. The mill location and the former rail corridor are no longer accessible.

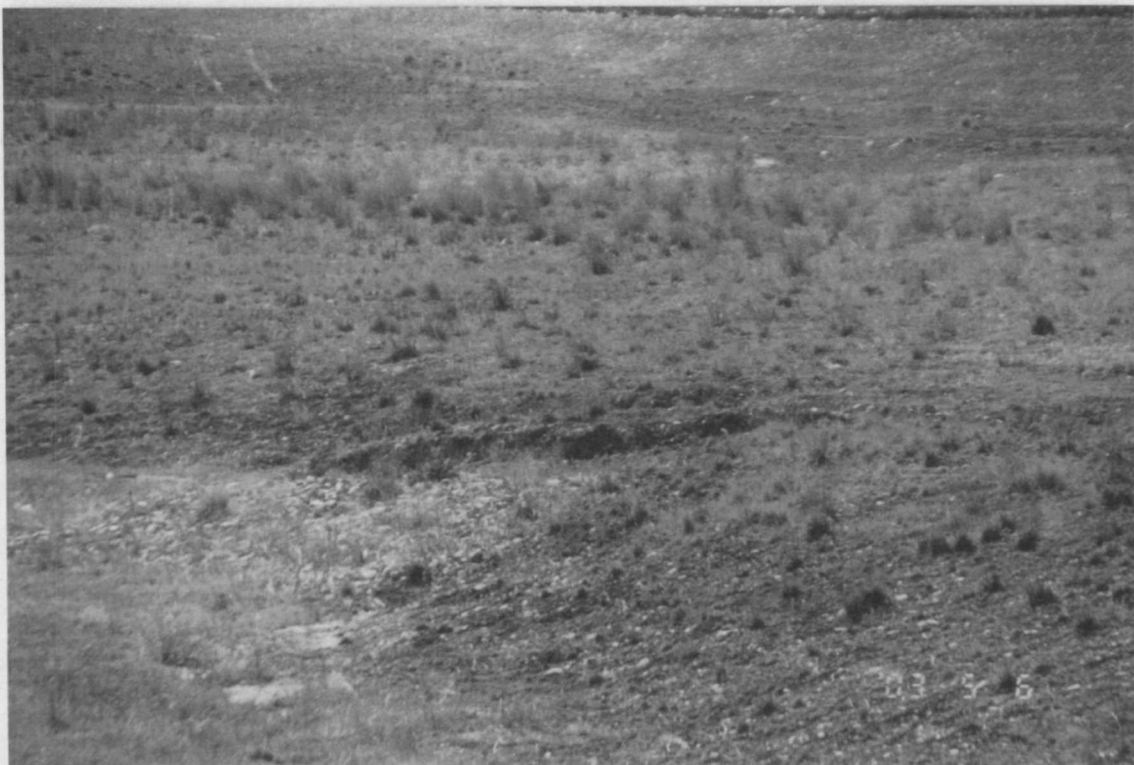
Gully forming in banks of Bingham Creek near intersection with Rt. 111.

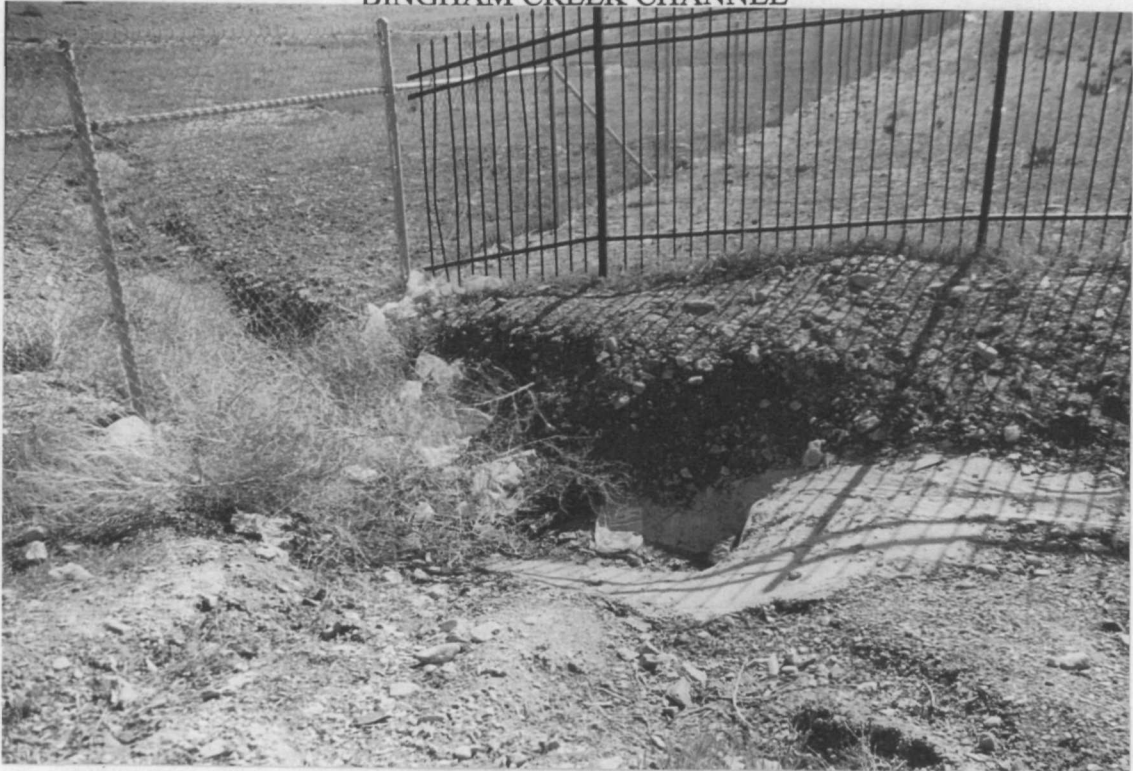
Ditch from highway and access road leading to erosion gully to Bingham Creek

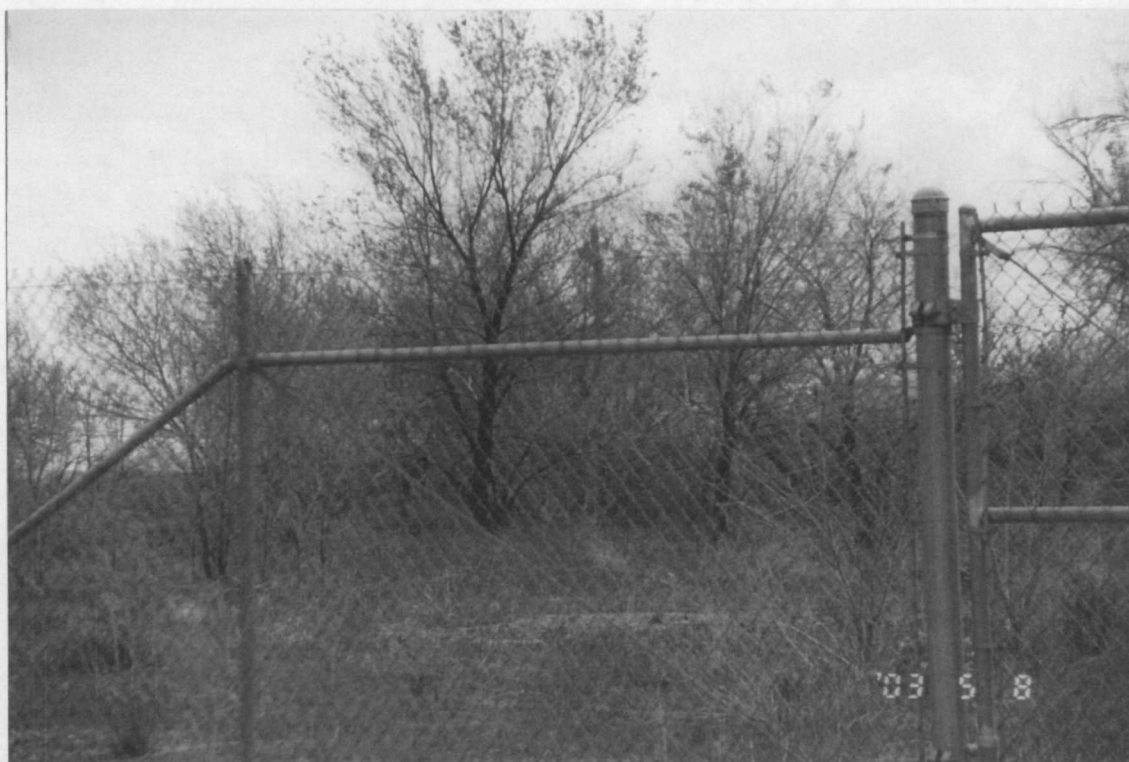
South end of Copperton Circle, tailings area still shows stressed vegetation

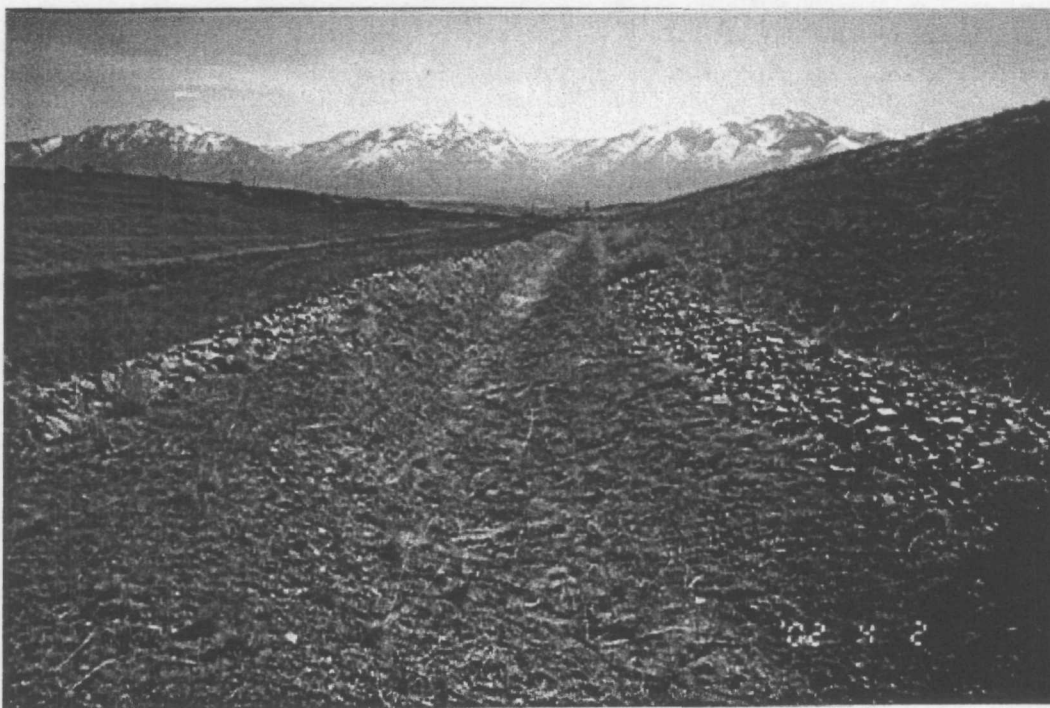
Perimeter drainage ditches were walked and examined for channel erosion, subsidence, bank slump, silt deposits and areas of ponding. All ditches appear to be functioning as designed and no erosion, slumping or subsidence was observed. High flow appears to have been between 8-10 inches depth in the south ditch and 4-6 inches deep in the north ditch. These flows did not erode the channel or wash out the vegetation that has become established in most ditches (see Photos No. 3-5).

Photo 3, SD No. 1, North Ditch (looking east)

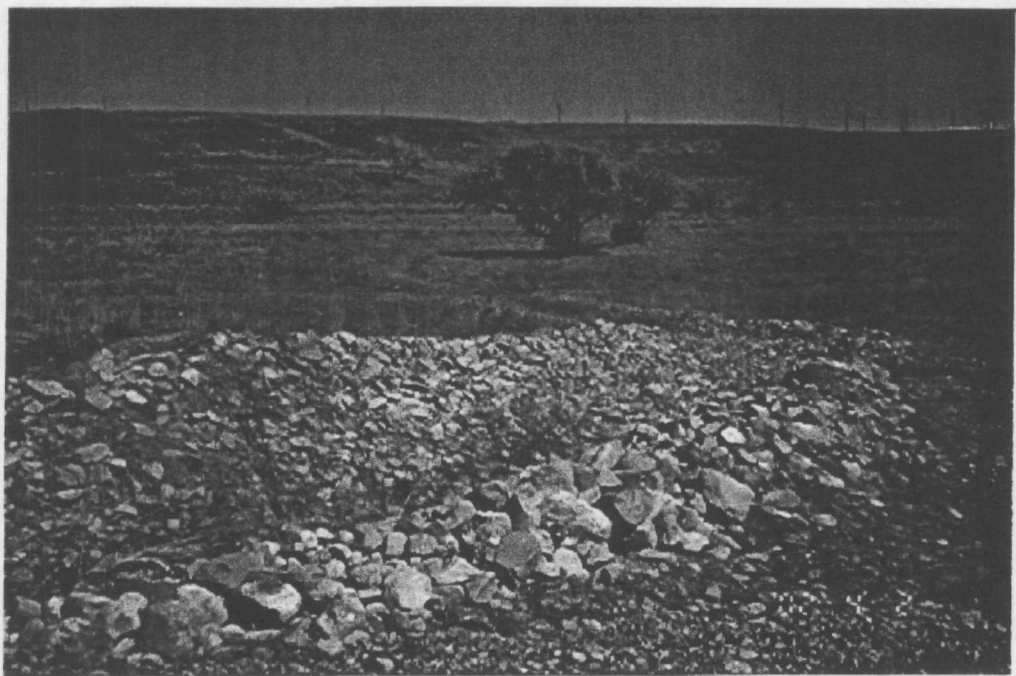
Drainage ditches carrying surface runoff water to the sedimentation pond were walked and found to be in excellent condition with considerable vegetation growth within the channel (see Photo 6).

Photo 6, SD No. 2E, Drainage Ditches Leaving Impound Area

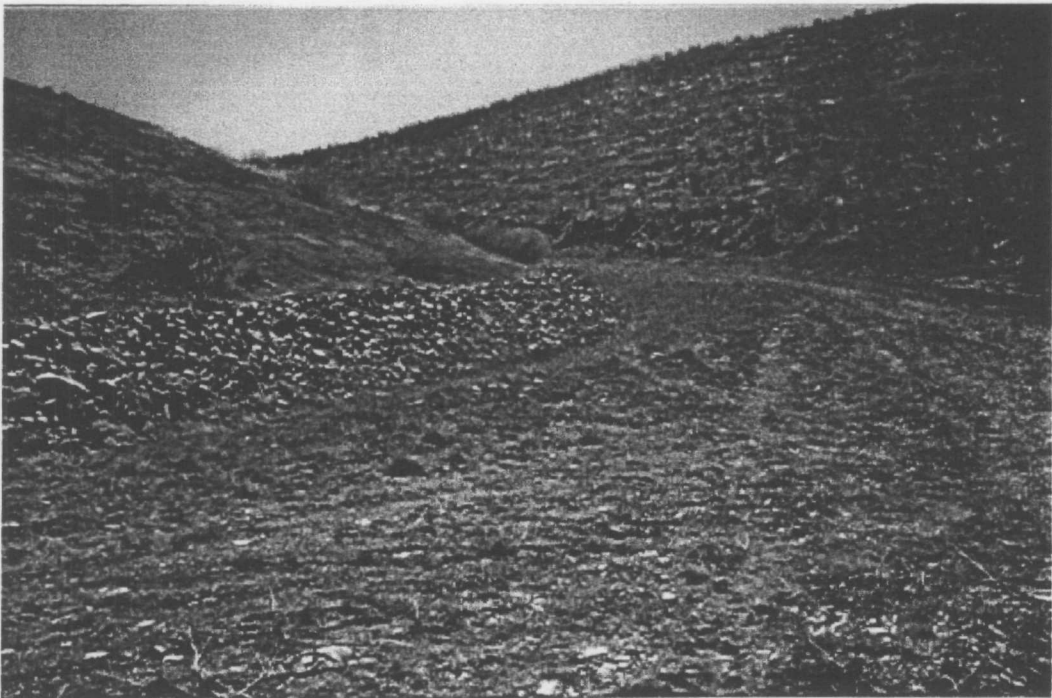
Areas of south hills scarred during construction of the impoundment have received seeding well and in most cases are more effectively covered with vegetation than are the natural hills. The exceptions are outcrops of dense clay strata which does not allow penetration of moisture to support growth. Some of these areas have small gullies of erosion, similar to the existing natural slopes in the area (see Photos No. 10-12).

Photo 10, Growth on Steep South Hill Borrow Area

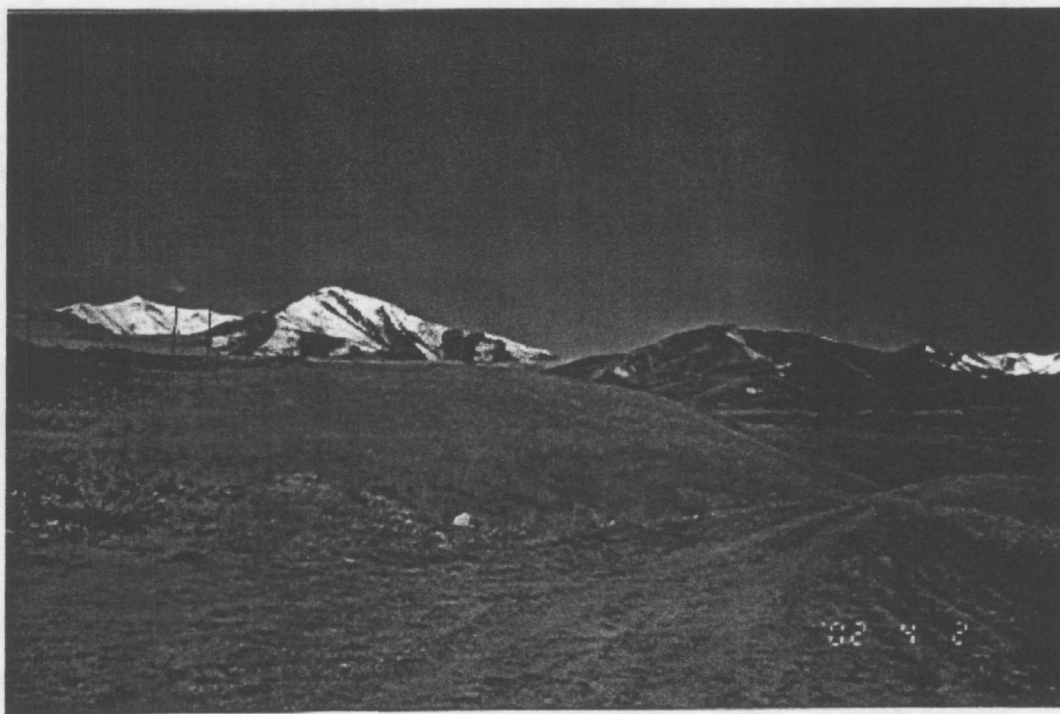
Photo 12, Growth on South Hills Borrow Area (looking west)

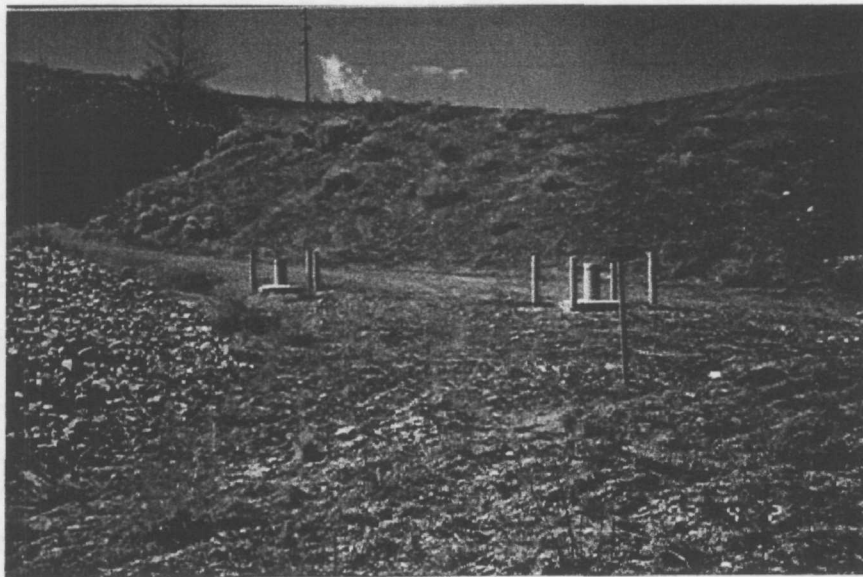
The monitoring wells were being sampled during the site inspection and were found to be in excellent condition. Security locks on well caps are in place and functioning.

Photo 13, Monitoring Wells MW4D and MW4S
